**ROLLING HILLS ESTATE LAKE DAM  
BUTLER COUNTY, MISSOURI  
MO 48077**

**PHASE 1 INSPECTION REPORT  
NATIONAL DAM SAFETY PROGRAM**

ROLLING HILLS ESTATES LAKE DAM  
BUTLER COUNTY, MISSOURI  
MISSOURI INVENTORY NO. 40077

PHASE I INSPECTION REPORT  
NATIONAL DAM SAFETY PROGRAM

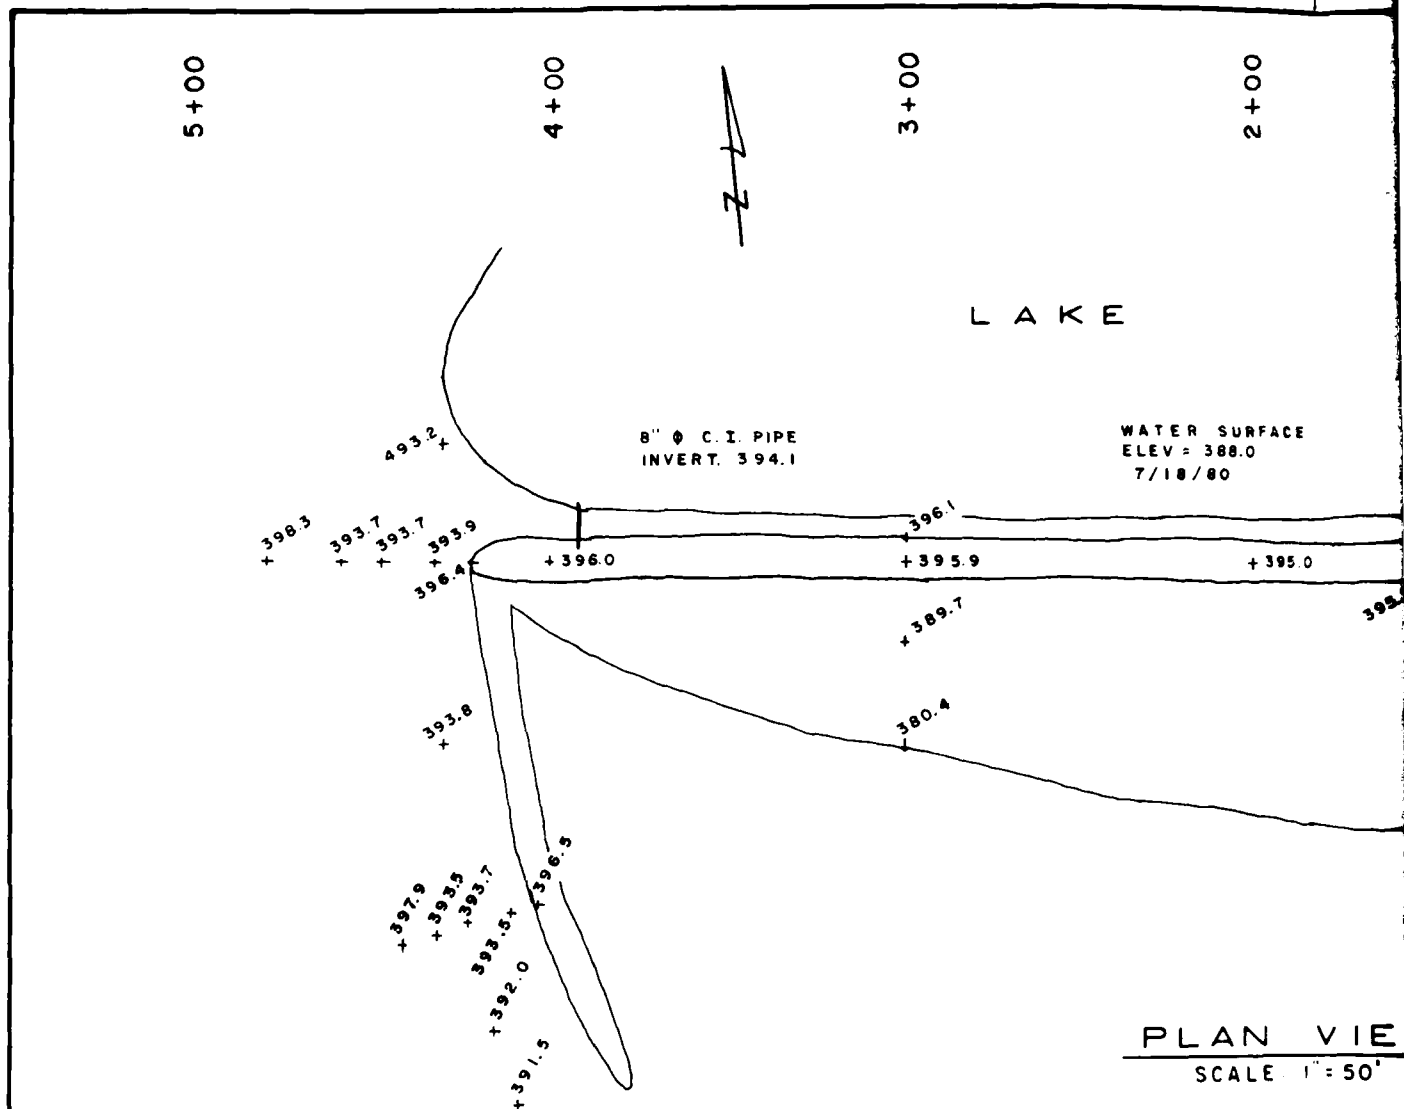
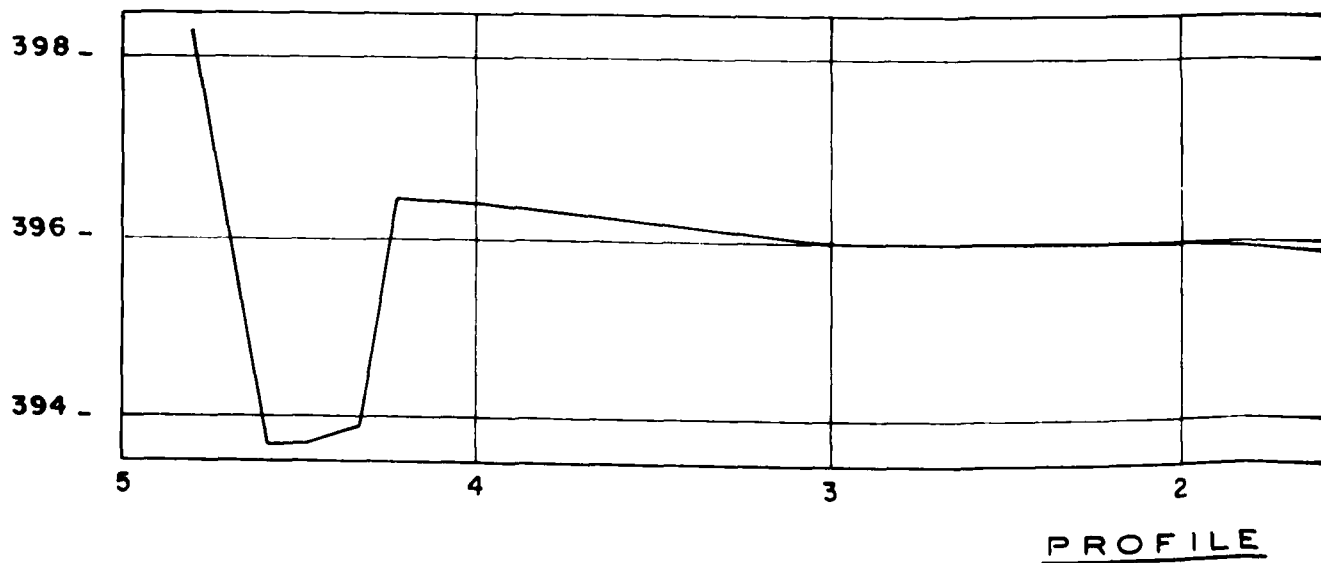
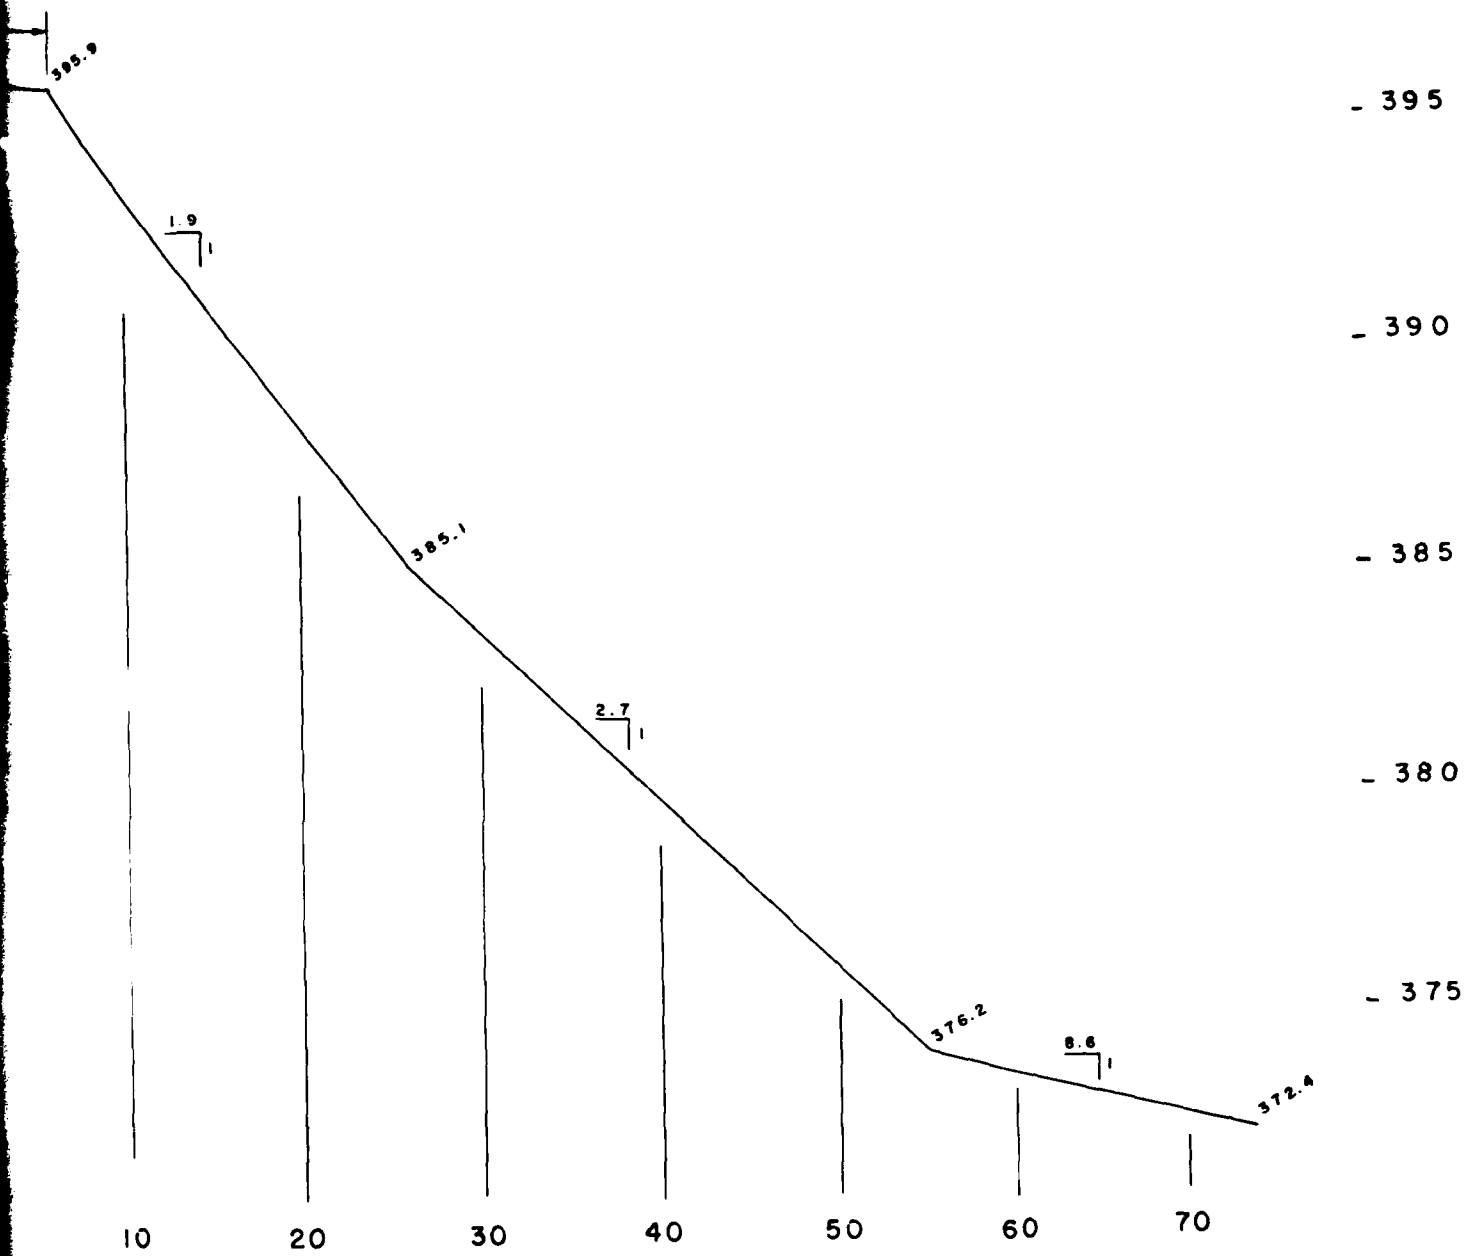
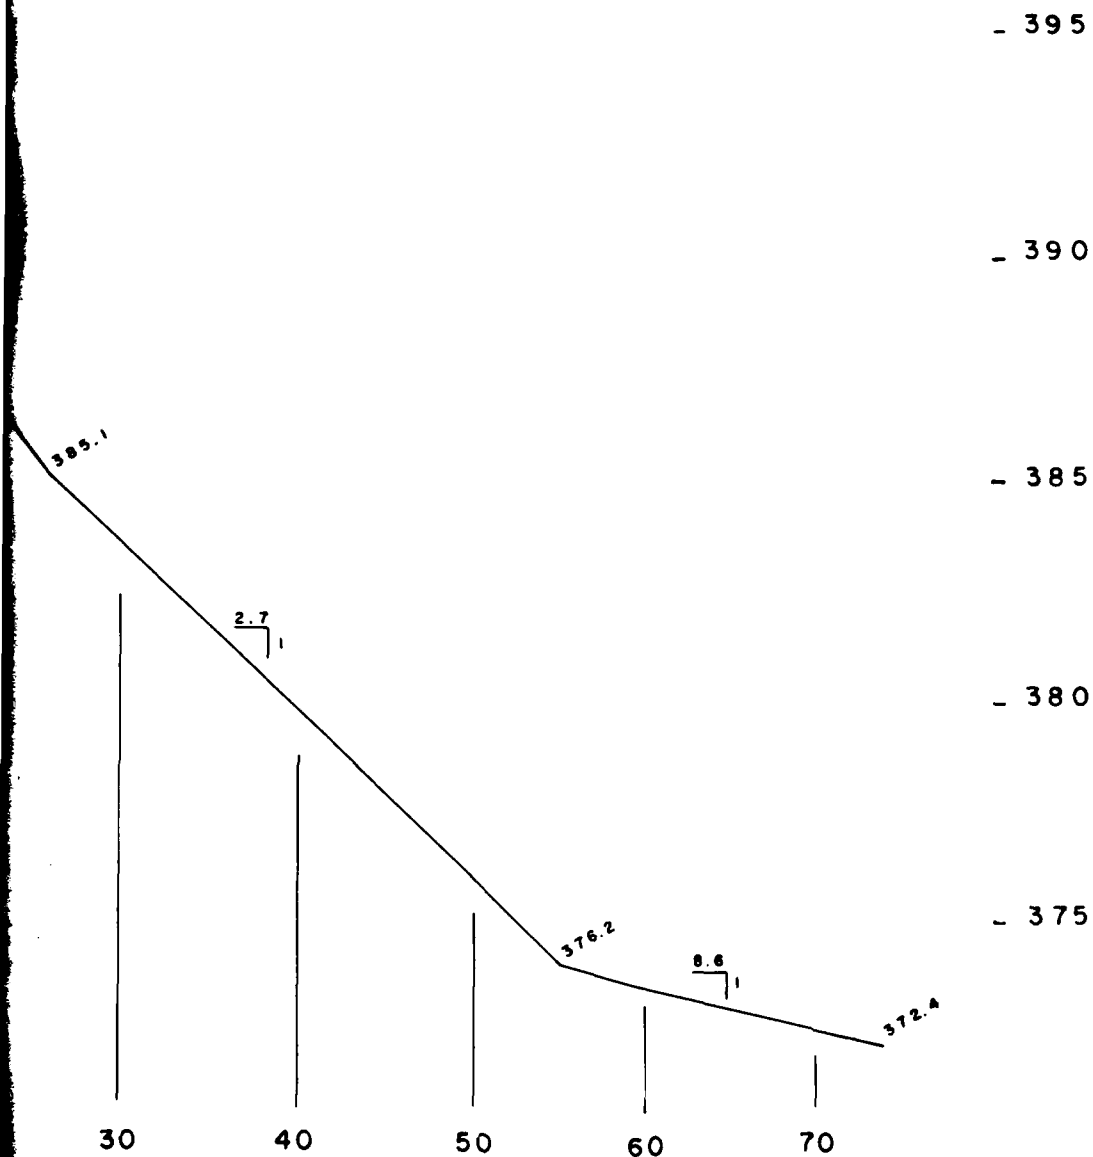
SHEET 3 APPENDIX A

Sheet 3 of Appendix A shows a plan, profile, and typical section of the embankment.
